**DEPARTMENT OF TRANSPORTATION****DIVISION OF ENGINEERING SERVICES**

Contract #: 04-0120F4Cty: SF/ALA Rte: 80 PM: 13.2/13.9File #: 69.28**WELDING INSPECTION REPORT****Resident Engineer:**Pursell, Gary**Address:** 333 Burma Road**City:** Oakland, CA 94607**Report No:** WIR-002513**Date Inspected:** 30-Apr-2008**Project Name:** SAS Superstructure**OSM Arrival Time:** 1400**Prime Contractor:** American Bridge/Fluor Enterprises, a JV**OSM Departure Time:** 2330**Contractor:** Zhenhua Port Machinery Company, Ltd (ZPMC), Changxing Island **Location:** Shanghai, China

**Bridge No:** 34-0006**Component:** OBG/Tower**Summary of Items Observed:**

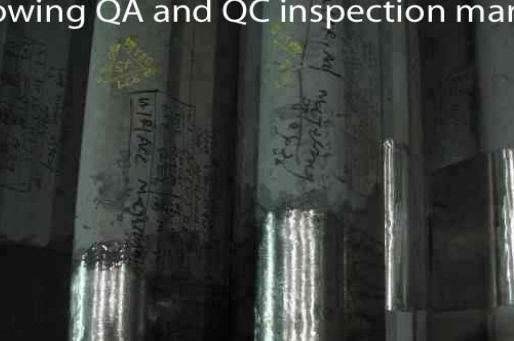
DP113-001-155 and DP113-001-156  
showing QA and QC inspection marks
